Proton Testing of nVidia GTX 1050 GPU

E.J. Wyrwas¹

NASA Goddard Space Flight Center Code 561.4, Radiation Effects and Analysis Group 8800 Greenbelt RD Greenbelt, MD 20771

Test Date: 9 April 2017 Report Date: 1 May 2017

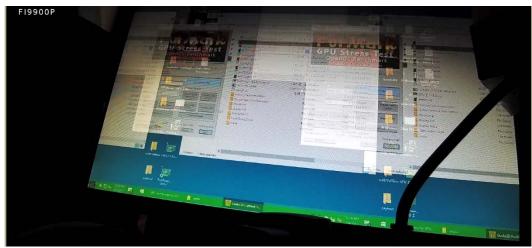
Figure 4: "Eyes in the Room" View of Graphics Artifacts during Irradiation

Event	Occurrence
System Halt, Power Reset	13
Pixel Artifacts	6
DUT unresponsive at test initiation	2
No noticeable events or system latency noticeable	9

It is also worth noting that upon power cycling the device, the device behaved normally. Further, no drift in temperature was noted other than a negligible increase due to computational loading.
